Correlations between wear mechanisms and rail grinding operations in a commercial railway

P.A Cuervo^{1*}, J.F Santa^{1,2}, A.Toro¹

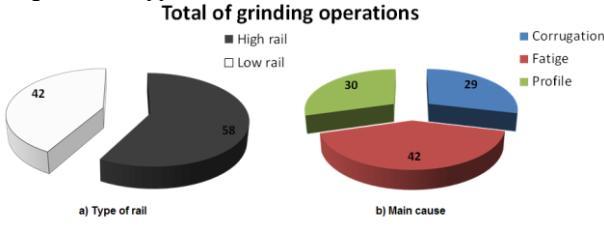
Figure 1. Details of grinding operations performed in the field during the last 9 years

Figure 1 shows the summary of the results of the grinding operations for the high and low rail (figure 1a) and as a function of the main cause of damage (figure 1b). Clearly, grinding the high rail is the most frequent operation in the field and the maintenance procedures are performed mostly because fatigue marks appear on the rail's surface.

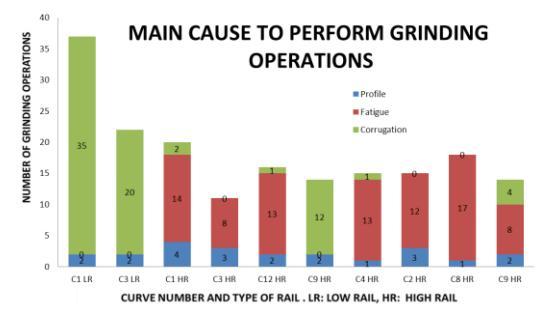
Figure 3. Main cause of rail grinding procedures for several curves with high wear rates.

Figure 3 shows the classification of the main causes of rail grinding procedures for several curves with high wear rates. Corrugation appeared preferentially on the low rail while fatigue was dominant in the high rail. The number of grinding procedures is higher for the curves showing corrugation.
